# Laser Cleaning Cylindrical Cells for Optimum Wire Bondability

Keywords: Cylindrical battery cell, laser cleaning, wire bonding

## Journal of Microelectronics and Electronic Packaging

Vol. 23, Issue 2, 2026

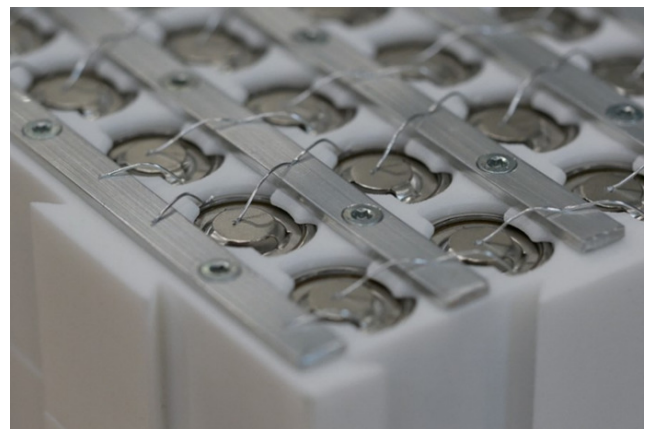
**Figure 1. Aluminum wire bonded battery module.**

Ultrasonic heavy aluminum (Al) wire bonding is a widely adopted interconnection technique for cylindrical lithium-ion battery cells, enabling electrical connection between individual cell terminals and common busbars within battery modules (Zwicker et al. 2020; Das et al. 2018). Owing to its room-temperature operation, compatibility with dissimilar metals, relatively low equipment cost, and suitability for automation, wire bonding remains an attractive solution for high-volume battery manufacturing despite the availability of alternative joining techniques such as ultrasonic welding, resistance welding, and laser welding (Das et al. 2018).

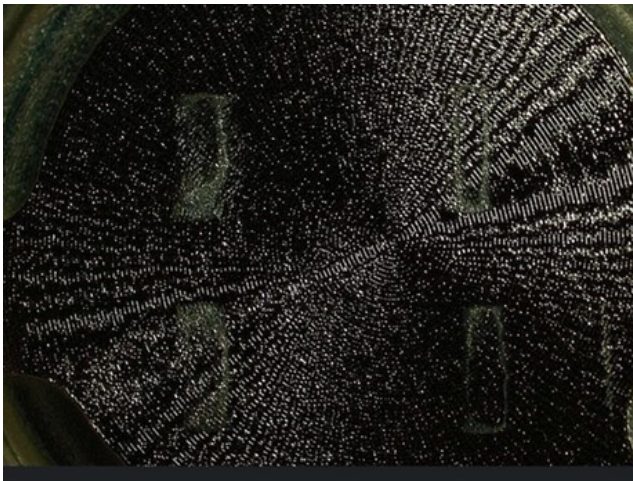
**Figure 8.** Unacceptable shear nuggets of four welds.

For the IPA cleaning method, the positive and negative terminals were manually wiped using lint-free wipes saturated with isopropyl alcohol. Single ribbon bonds were produced and subsequently evaluated by shear testing. Ten samples were tested. The measured shear strength values showed significant dispersion, ranging from 2.97 kg to 4.41 kg. In addition, the observed shear nugget coverage was below 10% of the bonded area. According to JEDEC shear test criteria, the minimum shear strength should exceed half of the tensile strength of the bonded ribbon and the shear nugget coverage should be at least 50% of the weld area (*Wire Bond Shear Test* 2017). The results obtained for IPA cleaning therefore indicate unacceptable bonding performance, as shown in [Figure 8](#).

A second cleaning method used a fiberglass brush to mechanically remove surface contamination. However, this approach introduces the possibility of cross-contamination because removed residues accumulate on the brush during repeated use. Shear testing of bonds formed after fiberglass-brush cleaning again showed a large dispersion in measured values. The shear strengths ranged from 3.75 kg to 5.23 kg, while the shear nugget coverage remained below 25%, which also does not meet the acceptance criteria.
